A Report on
Legacy Lodging Facilities
Operated by North Carolina State Parks

Prepared for the North Carolina General Assembly's
Fiscal Research Division and Joint Legislative Oversight Committee
on Agriculture and Natural and Economic Resources
by the N.C. Department of Natural and Cultural Resources

December 1, 2016

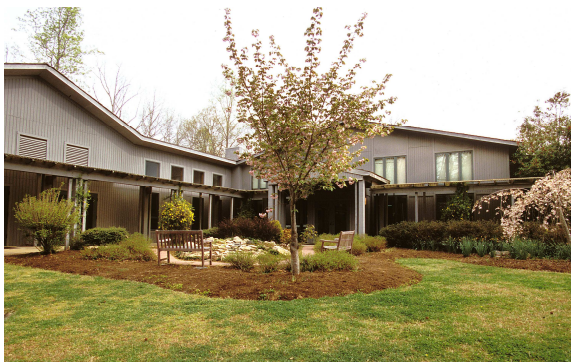
Main Lodge

The main lodge houses a large conference room, a small meeting room, park offices, large dining room and full service kitchen. This building provides meeting space for adults and larger groups, and serves meals to all visitors.

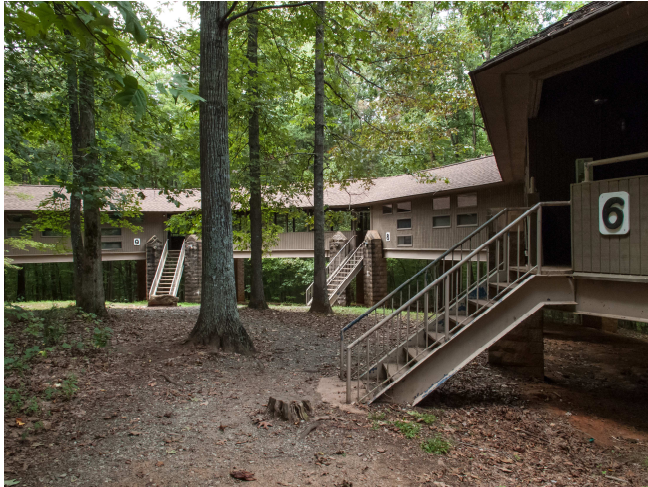
Interconnecting Cabin Units - Exterior

The round building is a two-story building which provides smaller meeting spaces and is used primarily for children, students and smaller groups. The 10 interconnecting cabins provide bunk-like rooms for groups of children and their chaperones with an exterior walkway along the contour of the cabins, providing a continuous path for wheelchairs and guests with other mobility issues.

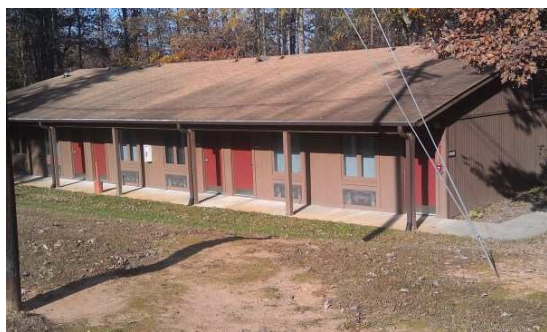
Motel-like Unit – Exterior

The four motel-like units with 12 rooms each are the only accommodations that might lend themselves to individual rentals rather than group use. Although the units have been renovated, they are still very sparse compared to private hotel rooms and do not contain televisions, telephones, or other amenities that private hotel visitors would expect. In addition, while the park is centrally located in the state, it is not near other businesses or venues that would be likely destinations for hotel visitors. There are no nearby restaurants or attractions, and the park itself is small. Demand for the rental of individual hotel rooms is unlikely to justify the cost of upgrading these rooms to hotel standards. Similarly, a hotel operation at this location is unlikely to be attractive or profitable to a private operator.

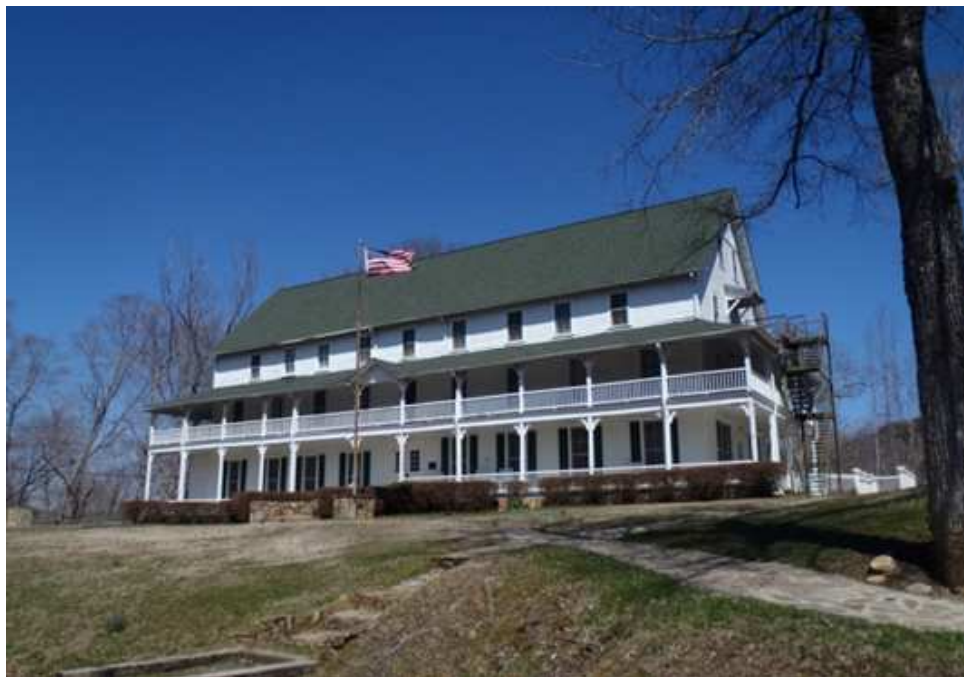
Cheshire Hall (The "Hotel")

Cheshire Hall, sometimes called the "hotel," is a picturesque three-story building built in 1924. It is a wood-framed and wood-construction building which has received various updates over the years. The building is heated on the first floor by propane, second floor by fuel oil, and the third floor is unheated. Due to the age of the building and associated inefficiencies, it is expensive to heat.

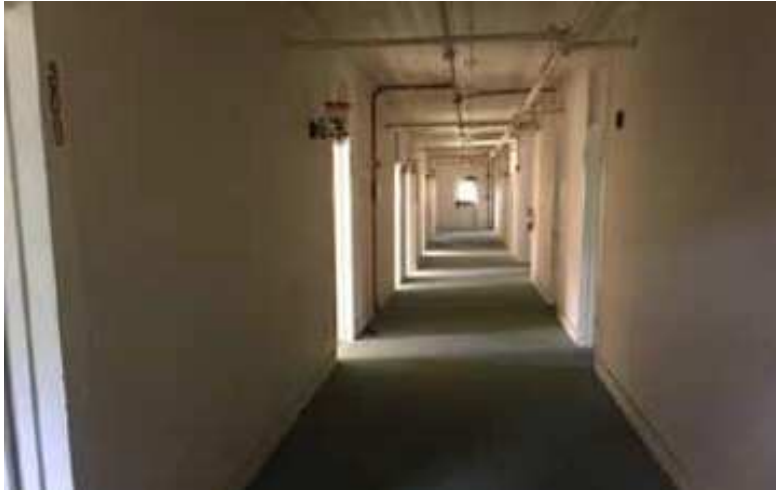
Cheshire Hall, Second Floor – Interior Hallway

The kitchen and dining area on the first floor were renovated recently, when the building was owned by NC State University. The electrical system, HVAC, lighting system, and emergency egress do not meet code and require major renovations. The upper two floors, which were previously hotel rooms, are in poor condition, with communal bathrooms typical of health springs resorts of the era. Significant costs would be associated with reconfiguring the space to include private bathrooms and other amenities expected in a modern hotel.

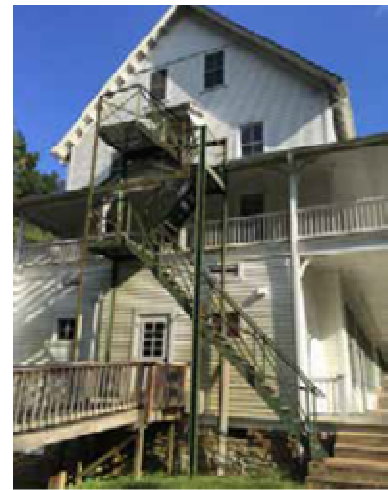
Inadequate Fire Egress

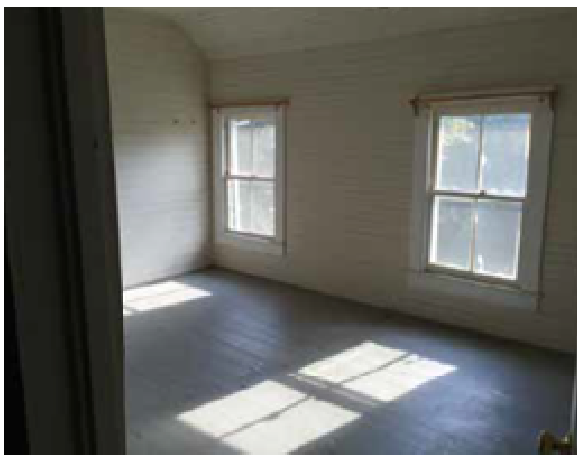
Cheshire Hall, Small Lodging Room

Cheshire Hall was historically used as a hotel and possibly could be renovated to be used as a hotel again. However, the rooms are quite small and do not have bathroom facilities. Communal restrooms are located at the ends of the halls. The building needs a great deal of renovation just to meet code, and the additional improvements needed to provide private bathrooms and other amenities for use as “hotel-type accommodations” are likely to be cost-prohibitive. Small rooms and communal bathrooms might be acceptable for use as hostel-type facilities for hikers and campers from the nearby Mountains-to-Sea State Trail or for scout groups and other organizations accustomed to fewer amenities. A plan for future renovation and use will be part of the upcoming master plan but conversion to a modern, privately-operated hotel is unlikely.

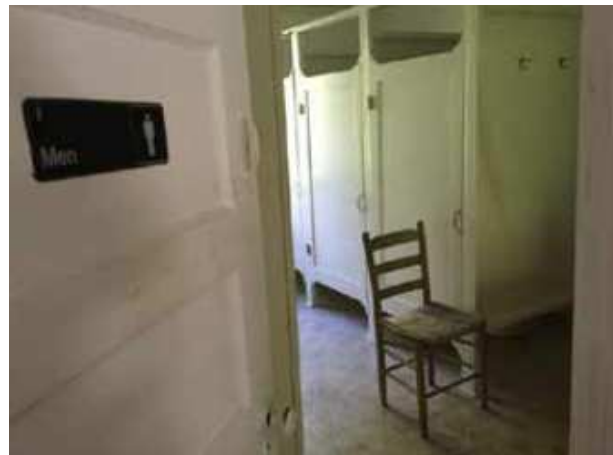
Communal Bathrooms
